THE NAVAL AVIATION SAFETY REVIEW

NOVEMBER 1961

**FLYING IN THE WORLD'S  
LARGEST ICEBOX**

<b>FLYING IN THE WORLD'S LARGEST ICEBOX</b> by CDR Alvin L. Morris, USNR	4
Antarctic weather and field conditions try even seasoned aviators' skills.	
<b>CRUISE CONTROL</b>	16
A look at the USS Forrestal, Air Group EIGHT and its accomplishments.	
<b>ARE YOU FLYING IAW?</b> by CDR C. A. Commander, USNR & LCDR R. B. Satterfield, USNR	18
Are you an aerial lawbreaker? Avert violations; review instructions now.	
<b>CLIFF HANGER</b>	26
Even with help close at hand your rescue may be delayed for some time.	
<b>BABY IT'S COLD OUTSIDE</b> by CAPT S. M. Williams, USMC	28
Disregarding the necessity for cold weather preparations may be serious.	
<b>SUIT YOURSELF AND SURVIVE</b>	30
So-called improvements to survival equipment may endanger your life.	
<b>POINT OF SURVIVAL</b>	34
Your survival knife is one of your most valuable pieces of survival gear.	
<b>NUTS AND BOLTS</b>	36
Correctly install that nut or bolt; errors cause accidents and injuries.

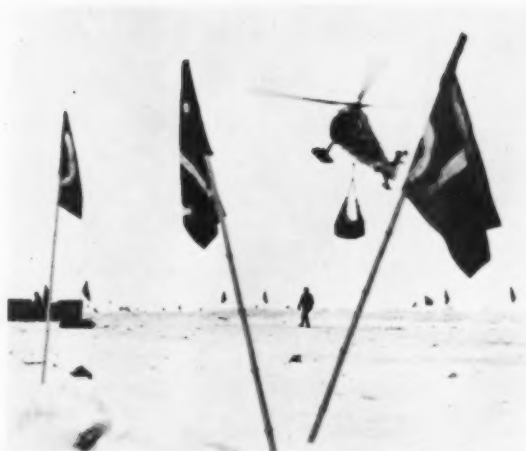
Flags, fuel drums, even rubbish are used to mark landing areas.

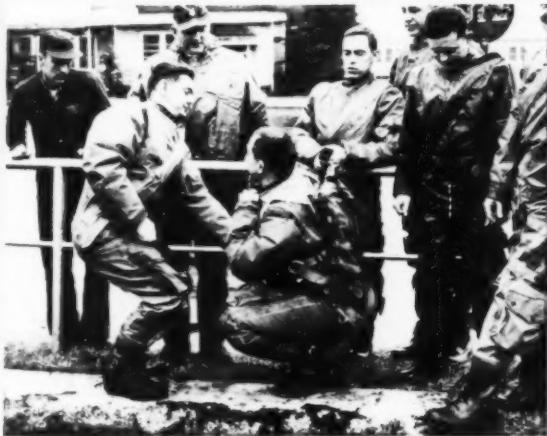
Members of VF-151 prepare to check the watertight integrity of their Mk IV antiexposure suits in the chilly 38° water of the NAS Atsugi supply sump.

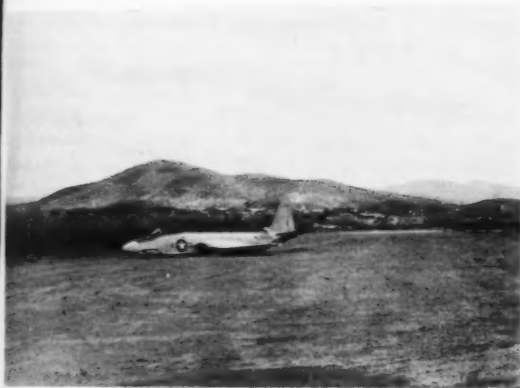
Emergency landing leaves forlorn aftermath

This tired old F2H-3 was going to the boneyard at NAF Litchfield, Arizona but the pilot became lost on top of an overcast and with fuel at a decision point (400 pounds) he spotted a small dirt airstrip in the mountains and bellied it in. As it turned out the location was 90 miles south of the Border.

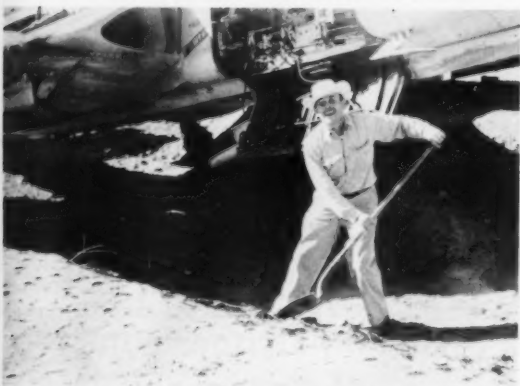
A few shovels full before dropping the gear

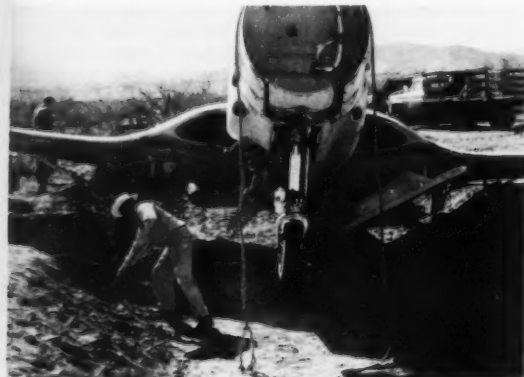
Almost ready to move out

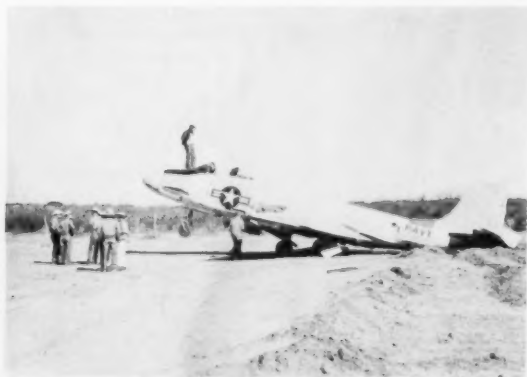
Final weight and balance is awful

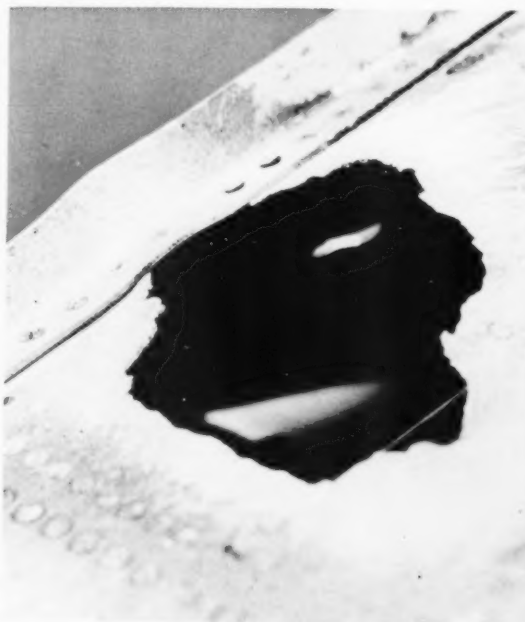
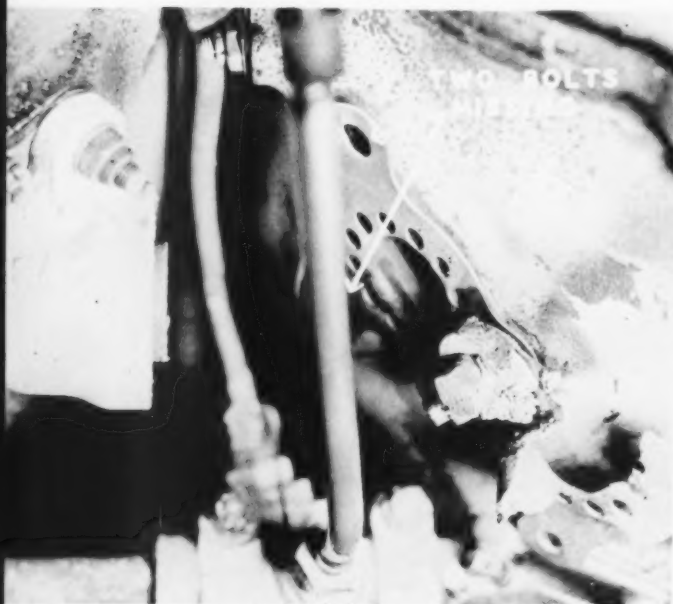
This F9F-8 had flown 13.3 hours since coming out of check (180 hr. 2nd intermediate). On this flight the pilot noticed nothing wrong until after shutdown. As the pilot got out of the aircraft he noticed smoke coming from the port intake. He then saw smoke coming from under the fuselage. Investigation revealed a hole in the bottom of the fuselage and a burned out interconnector between the No. 5 and No. 6 combustion chambers (See photo).

Only one bolt was found securing the interconnector elbow on combustion chamber No. 5. This was due to the other two bolts being improperly installed, or possibly not installed during the last intermediate inspection.

This condition allowed combustion gases to burn the elbow fitting which subsequently failed on this flight. This failure then allowed combustion gases to burn a hole in the aircraft near the No. 5 and No. 6 combustion chambers.

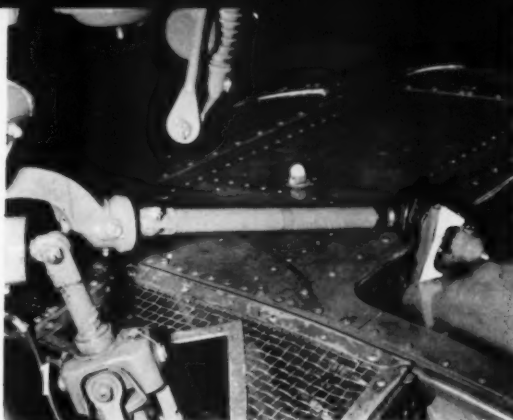
This accident occurred in the process of folding the HSS-1's forward starboard rotor blade. The horn locking pin was partially removed, then the taper pin removed and the blade walked aft with the horn assembly breaking as the blade reached approximately 45 degrees.

Horn assembly was broken approximately two inches from the control rod assembly, see photos 1 and 2, requiring replacement of the rotor head.

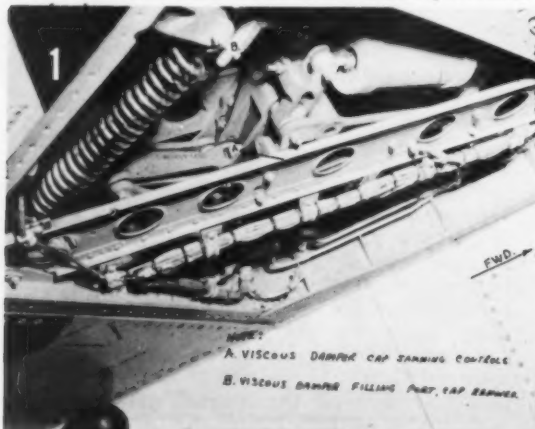
The established factor of other personnel is assigned to this report because the AN no. 4 cap from the aft viscous damper was found lodged in the UHT variable gain idler linkage (Part CV15-158074-1(2)). This cap was evidently dropped during servicing because another cap was found installed on the viscous damper during the investigation. The normal terminus of objects dropped through the servicing access is in the variable gain idler linkage (See photo 1).

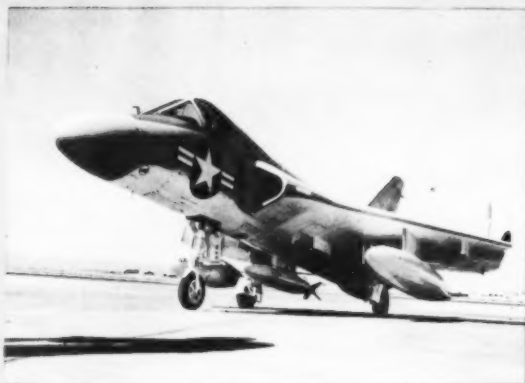
**F**AILURES of the nose wheel and tire on the F4D has been a continual problem during carrier operations. Here's VF-13's own story of how a determined maintenance crew controls this problem. It is felt that this is a good example of what initiative and determination can contribute to aircraft safety.

VF-13 experienced numerous failures of F4D-1 nose wheels and tires after beginning shipboard operations in May 1960. The nose wheels failed on the initial down thrust of the strut during the catapult shot. As the shock passed down the strut to the wheel, it bottomed the wheel rim on the deck, cracking and chipping the assembly. The tires were blown on landing if they had not already blown on the catapult shot.
